Intel® Acceleration Stack for Intel® Xeon® CPU with FPGAs Version 1.1 Release Notes

Intel FPGA Programmable Acceleration Card N3000

RN-1219 | 2019.11.25

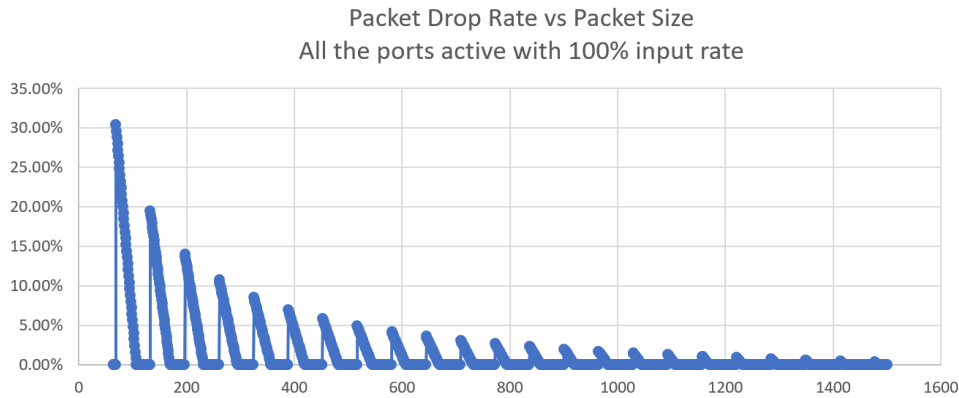
Figure 1. Predicted Packet Loss Rate for 2x2x25G and 4x25G Configurations

The FPGA factory image multiplexes all the Ethernet ports into one 512-bit (64 byte) bus. This bus has enough bandwidth to transport all the Ethernet ports when the packet size is a multiple of 64 bytes. When packet sizes are not multiples of 64 bytes, the last transfer of the packet on the bus carries the remainder of packet and the unused byte lanes do not carry valid data. For these packets, the bus does not have sufficient bandwidth to carry all traffic for some packet sizes. As a result of lack of bandwidth, the packet drops.

During internal tests, if all ports are active with fixed size packets that are not multiples of 64 bytes, some packet loss may occur. The worst case is 69-byte packets where the cyclic redundancy check (four bytes) is stripped off, resulting in 65 bytes transferred on the internal bus. This packet transfer takes two clock cycles. The first clock cycle transfers 64 bytes and the second clock cycle transfers one byte.

The following figure shows the predicted packet loss rate for the 2x2x25G and 4x25G network configurations when all the ports have 100% input capacity and same packet size.

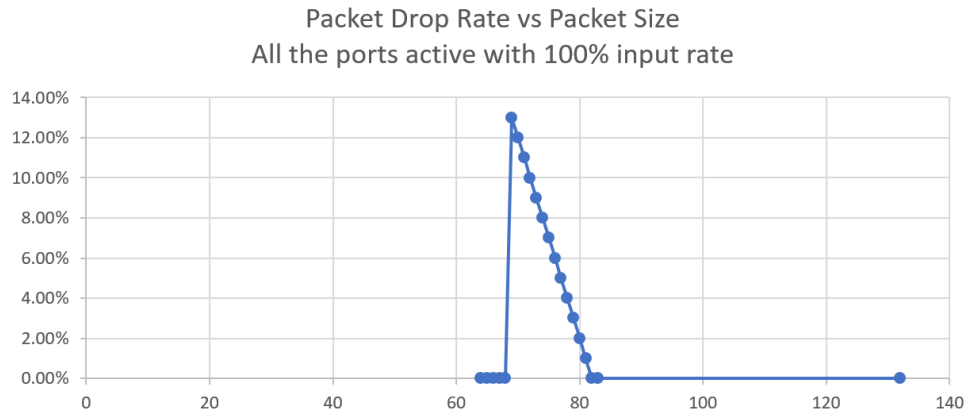
Figure 2. Predicted Packet Loss Rate for 8x10G Configuration

The following figure shows the predicted packet loss rate for the 8x10G network configuration when all the ports have 100% input capacity and same frame size. Packet loss only occurs for packet sizes between 69 bytes to 82 bytes.
